Determination and Prioritization of Geotechnical Issues for MoDOT

Research Development and Technology

Missouri
Department
of Transportation

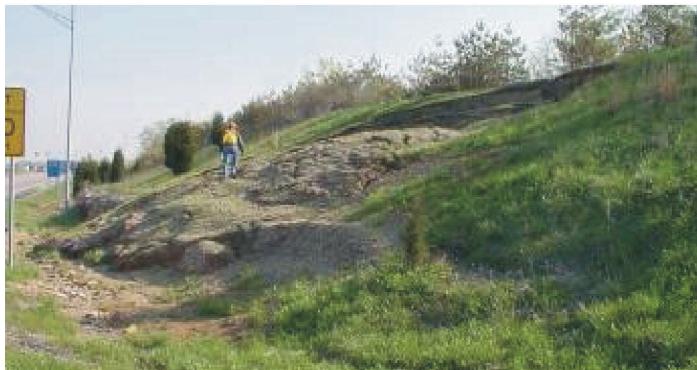
Figure 2
Slope Instability Observed During Survey

The top four geotechnical related challenges facing the Districts include: slope instability (soil); pavement (in terms of stability, sub-base support, and drainage); erosion control (both on new construction and long-term facilities) and bridge approach slabs. Every District reported soil slope instability as a major issue, typically in the top three concerns for the District (Figure 2). Field visits revealed the slopes to be too steep and of marginal

strength materials. Erosion issues observed included steep slopes, concentrated drainage or inappropriate materials being placed in areas of concentrated drainage (Figure 3). Pavement problems were extensive across the state, i.e., poor quality surface and failure of pavement

- Specific research needs of high priority.
 - A detailed database on the costs of initial construction and maintenance of soil slopes is paramount to the effective reduction of effort and cost for remediation of failures of these slopes. A systematic evaluation of specific slope repair methods should be conducted.

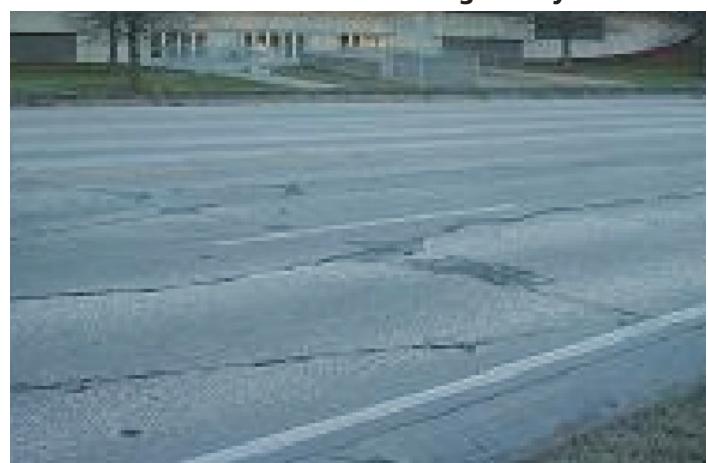
Figure 4
Pavement Problems Observed During Survey

(Figure 4). The causes include: poor subsurface drainage, inadequate sub-base support, expansive soils and settlement. All Districts cited bridge approach slabs (BAS) as problematic (Figure 5). The redesign (c. 1993) has not alleviated the “bump at the end of the bridge.” Causes varied from design of the approach slab to construction/inspection practices. Pavement edge drains (PED) appear to be working satisfactorily when the pavement has enough structural thickness. However, when the installation of the PED was not associated with other pavement improvements, the performance did not improve.

- Develop a spatial comparison of pavement ratings and maintenance/repair intervals correlated with pavement types, subsurface drainage systems and subsoil types among other parameters and verify with well-instrumented study of edge drains in new and remedial construction.
